Baltimore, Maryland
NOISE-CON 2010
2010 April 19-21

Flanking paths associated with exposed roof decks in condominiums

Jeffrey P. Kwoikoski^{a)}
D. L. Adams Associates, Inc.
1701 Boulder Street
Denver, CO 80211

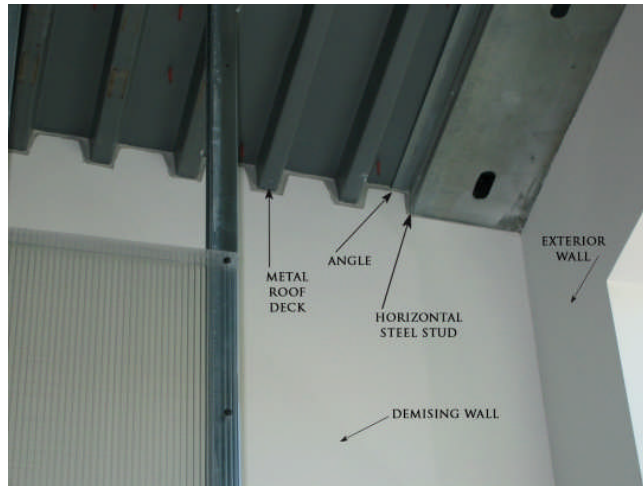
Fig. 2 - Photograph of horizontal stud.

I was able to use a ladder to observe the top of the wall near the metal roof deck. Sound appeared to be coming from a horizontal 305 mm (12") steel stud that penetrated the wall against the underside of the roof deck at the exterior wall. Refer to Fig. 2 for a photograph of this condition.

The contractor indicated that the horizontal stud served as bracing during construction. There was no gypsum board behind the stud (between the stud and the roof deck). The stud was no longer needed structurally, however, the stud was an integral part of the appearance of the units now and could not be removed to seal the hole in the gypsum board.

The sound was traveling into the stud on one side of the wall, laterally through the stud and through the hole in the wall, and then out the exposed stud on the other side of the wall. We decided that the most reliable solution was to wrap the horizontal stud within a unit, from the demising wall on one side to the demising wall on the other side.

First, fiberglass batt insulation was stuffed into the stud (through holes in the stud) as much as possible within about one meter of each side of the wall to provide sound absorption inside the stud cavity. Then the stud was covered with cellulose fiberboard to add mass to the sound barrier on each side of the wall. The fiberboard was fastened directly to the underside of the stud. Finally, the fiberboard was covered with sheet metal for aesthetic purposes. Refer to Fig. 4 for the detail. This detail was implemented in two side-by-side condominiums.

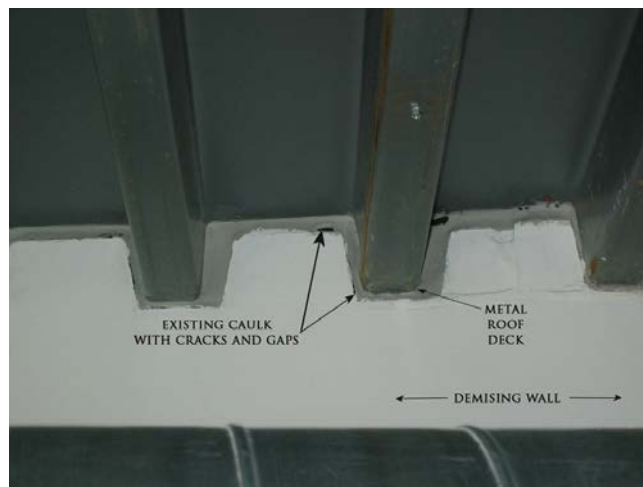
Fig. 3 - Photograph of joint between wall and roof deck.

The joint between the top of the wall and the metal roof deck was caulked, but the caulk had cracked in many places and no longer provided an airtight seal. Sound was likely leaking through this joint. Refer to Fig. 3 for a photograph. There was no caulk between the bottom of the wall and the concrete floor slab.

The joint at the top of the wall was recaulked on each side. The joint at the floor was caulked on both sides.

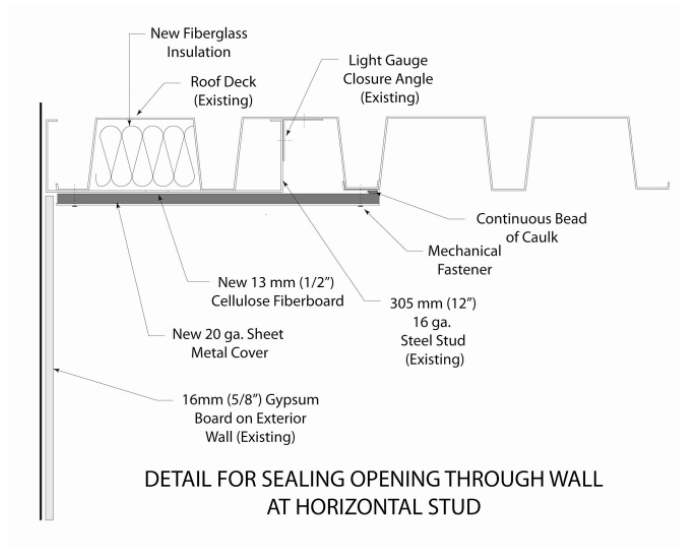
Fig. 4 - Detail to seal wall at horizontal stud.

The hole in the gypsum board at the horizontal stud penetration, on each side of the demising wall, was approximately 305 mm (12") wide by 76mm (3") high. The gypsum board was tight all around the stud, but it did not fill inside the "C" shape of the stud. The hole was not easily accessible. We considered various methods to attempt to fill the holes with expanding foam, grout, caulk, and other materials, but could not be confident that the hole would be completely filled and sealed.

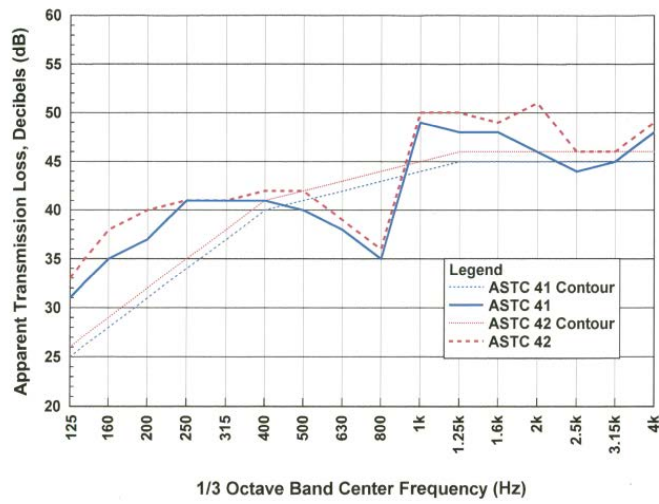
Fig. 5 - ASTC test results.

In July of 2008, a test was performed on one demising wall between units. The intent of the test was to determine the ASTC and evaluate additional flanking paths, including the roof deck. The ASTC was 41. Refer to the "ASTC 41" curve in Fig. 5 for the test results, and refer to Fig. 6 for the floor plan of the two units. The ASTC rating was limited by the large dip in sound Transmission Loss at 630 Hz and 800 Hz.

The ASTC 41 rating was well below the design rating of STC 58. The ASTC 58 rating requires properly designed and installed resilient channels. However, the resilient channels would have to be completely ineffective to account for the ASTC 41 rating, and the dip in Transmission Loss at 800 Hz was not typical of resilient channel problems. The obvious airborne flanking paths and leaks noted during our first visit had already been remedied before the ASTC test. Based on the test results, it appeared that significant flanking paths still existed.

A second ASTC test was performed. The ASTC test result was 42. The ASTC increased by one point. Sound transmission loss increased somewhat below 250 Hz and above 800 Hz, but the ASTC was still limited by the dip at 630 Hz and 800 Hz. Please refer to the "ASTC 42" curve in Fig. 5. Subjectively, the strongest sound appeared to be coming from the roof deck. Sound was audible in the exterior wall to a lesser degree.

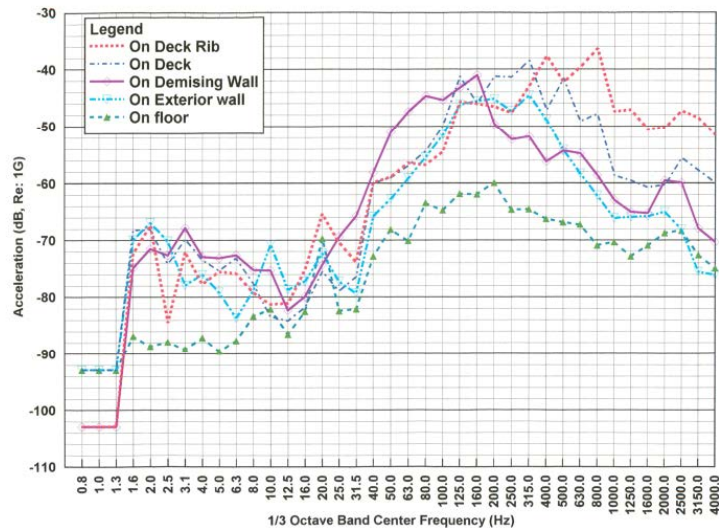
Fig. 7 - Vibration measurements.

During the ASTC testing, vibration was measured on several surfaces on the receiving side of the test wall while pink noise was generated at high levels on the source side. A Larson Davis 2900 real time analyzer was used together with a Brüel & Kjær Type 4370 54 gram accelerometer to measure vibration levels in one-third octave bands and narrow bands. The vibration levels were averaged over 30-second durations. Acceleration was measured on the demising wall, on the exposed roof deck at a location 914 mm (36") from the wall, on the concrete floor, and on the exterior wall. The measured acceleration levels are plotted in Fig. 7.

The "deck" measurement was taken on the upper flat portion of the deck (the highest point). The "rib" measurement was on the rib of the deck (the lowest point). Note that the "rib" acceleration levels peak at 800 Hz, while the "deck" measurements peak at 400 Hz. The rib vibration correlated much closer to the dip in Apparent Transmission Loss evident in the ASTC tests. The acceleration levels on the walls and floor at 630 Hz and 800 Hz were more than 15 decibels below the levels on the roof deck ribs.

The vibration peak at 800 Hz on the rib of the roof deck correlated to the dip in apparent transmission loss in the ASTC test results. Using the acceleration levels on the deck, we estimated the sound pressure level in the room that should be expected from the acceleration levels on the roof deck². We estimated a sound pressure level of approximately 55 decibels at 630 Hz and 800 Hz. The ASTC receiving room measurements made simultaneously with the vibration measurements were 55 and 55 decibels at 630 Hz and 800 Hz, respectively. We now had a good indication that structureborne flanking through the roof deck would need to be addressed in order to achieve an ASTC 45 between condominiums.

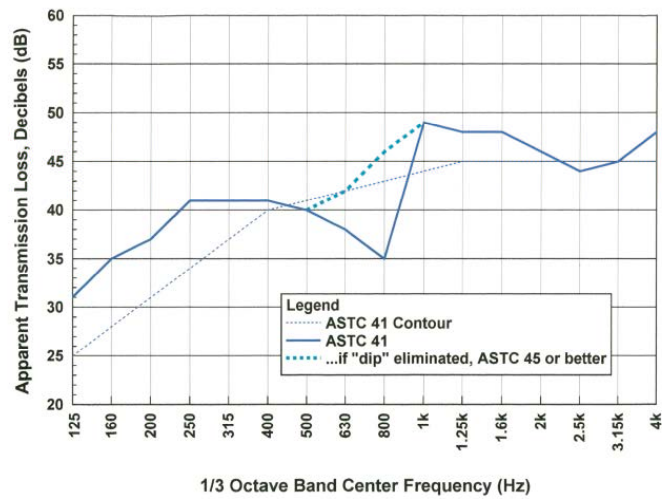
Fig. 8 - ASTC estimate if “dip” eliminated.

From the first ASTC test plot, it was clear that if the dip at 630 Hz and 800 Hz could be eliminated, the wall should yield an ASTC 45 or better. Refer to the illustration in Fig. 8. The challenge was how to achieve this.

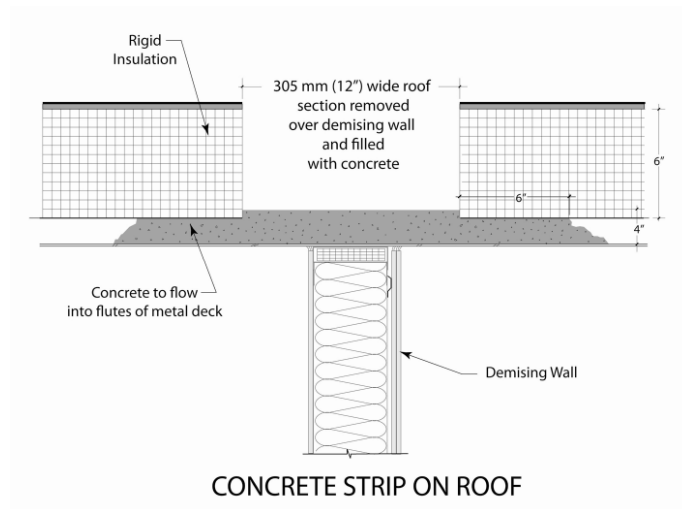
Fig. 10 - Concrete strip detail.

Although concrete over the entire roof deck was not feasible, the structural engineer indicated that a small strip of concrete directly over the load-bearing demising walls was feasible. The narrow strip of concrete was not going to be as effective as covering all or most of the roof deck¹, and predicting the improvement that could be expected was difficult. However, we felt that it should give some improvement, and only three to five decibels of improvement at 800 Hz was needed to raise the ASTC to 45 or better. We also expected that pouring the concrete would at least partially seal the joint between metal deck sections. Refer to Fig. 9 for an illustration of where the leaks occurred at the metal roof deck joints. If any sound was traveling over the wall through the hollow "channels" created between the deck flutes and the rigid insulation, the concrete strip would close this path as well. The concrete strip option was

deemed the best option available and the contractor decided to try the approach over the test demising wall. See Fig. 10 for the detail that was used.

In September 2008, the roof was cut and a concrete strip was poured over one wall. Approximately one week later, the ASTC of the wall was measured to be ASTC 46 - an improvement of 4 points from ASTC 42. The plotted data is shown in Fig. 11. The Apparent Transmission Loss was improved by 3 and 5 decibels at 630 Hz and 800 Hz, respectively.

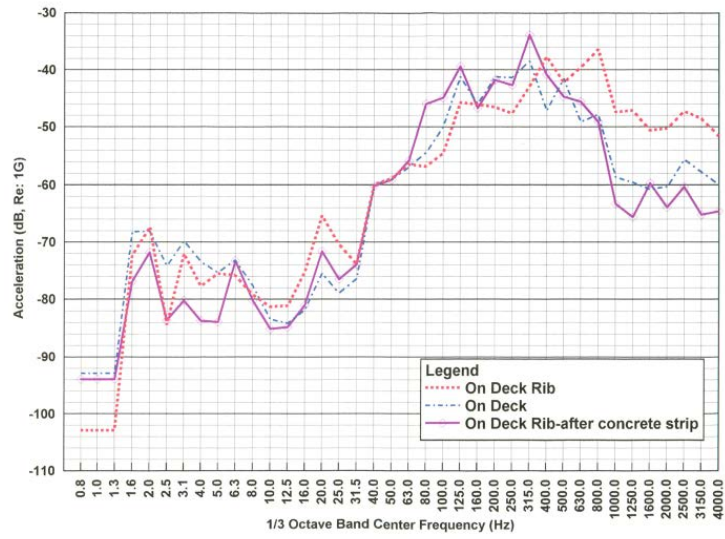
Fig. 12 - Vibration measurements after concrete strip installed.

Vibration levels were remeasured in the same locations. The results are shown in Fig. 12. The acceleration level at 630 Hz and 800 Hz was reduced by 6 and 13 decibels, respectively.
