Baltimore, Maryland
NOISE-CON 2010
2010 April 19-21

Flanking paths associated with exposed roof decks in condominiums

Jeffrey P. Kwoikoski^{a)}
D. L. Adams Associates, Inc.
1701 Boulder Street
Denver, CO 80211

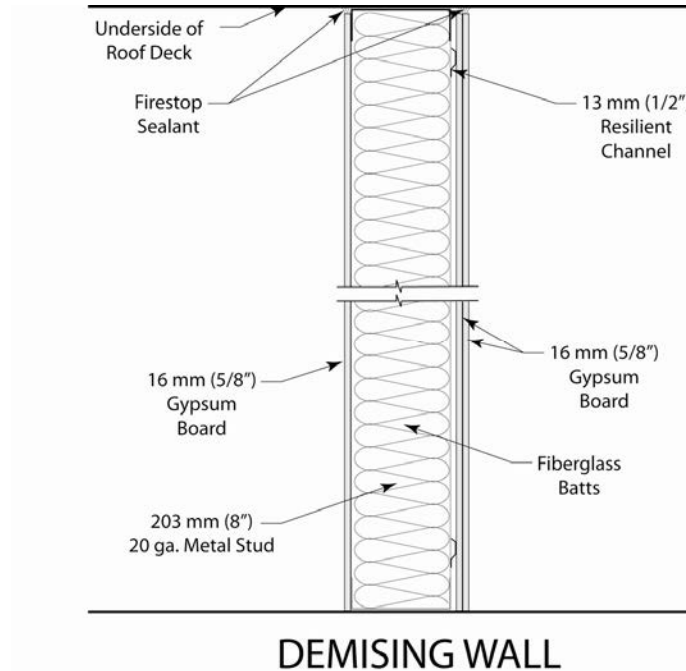
Fig. 1 - Demising wall construction.

Before visiting the site, we evaluated the demising wall construction. According to the drawings and statements from the general contractor, the demising wall consisted of one layer of 16 mm (5/8") gypsum board on one side, and two layers of 16mm (5/8") gypsum board on the other side of 203 mm (8") deep 20 gauge metal studs, placed 406 mm (16") on center. The stud cavity was filled with fiberglass batt insulation. The gypsum board on one side of the wall was mounted on 12 mm (1/2") resilient channels. The total wall thickness was 251 mm (9-7/8"). Please refer to Fig. 1 for the wall construction. We estimated the wall's Sound Transmission Class (STC) to be approximately 58. We would not expect the complaints that the owner was receiving if the wall was built properly and there were minimal sound flanking paths.

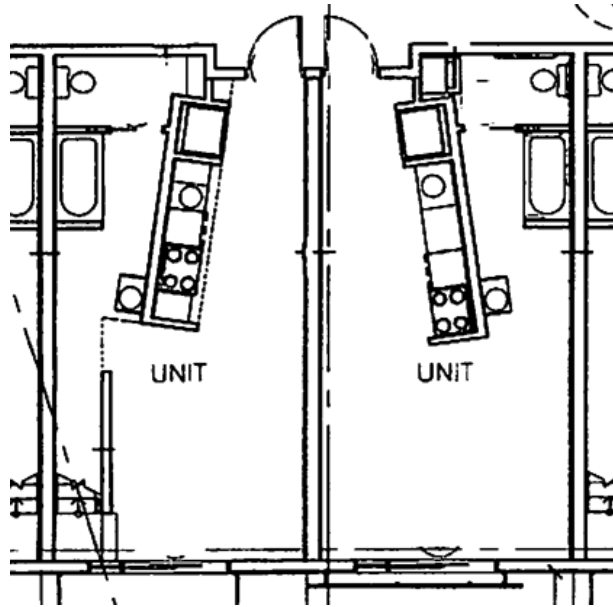
Fig. 6 - Floor plan of test units.

In July of 2008, a test was performed on one demising wall between units. The intent of the test was to determine the ASTC and evaluate additional flanking paths, including the roof deck. The ASTC was 41. Refer to the "ASTC 41" curve in Fig. 5 for the test results, and refer to Fig. 6 for the floor plan of the two units. The ASTC rating was limited by the large dip in sound Transmission Loss at 630 Hz and 800 Hz.

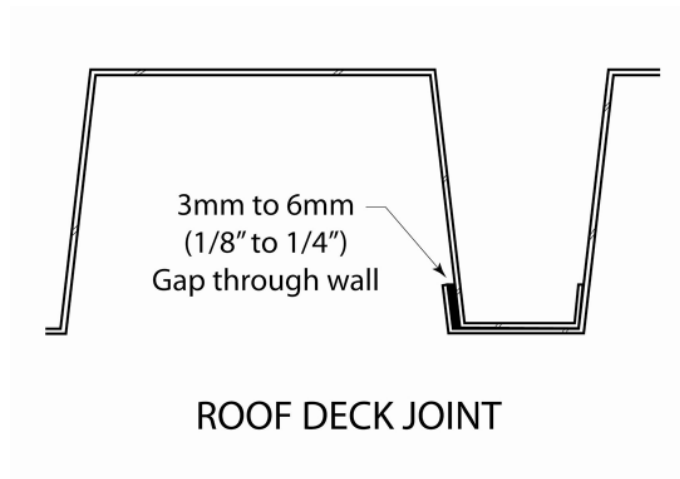
Fig. 9 - Detail of joint in metal roof deck.

Wherever they were accessible, these joints were caulked on each side of the wall, from the wall out for a distance of approximately one meter out from the wall. The joints occurred every 610 mm (24"). The investigation also revealed several concealed conditions where airborne sound leaks were still present.

In each case, sound leaks were identified and repaired. When conditions were found that were likely to occur in other similar units, the similar units were investigated and repaired if necessary. The walls below ASTC 45 were re-tested, and in some cases, repaired further and re-tested again. In all cases the walls were brought up to ASTC 45 or better.
